Confidential Property Inspection Report

Prepared for: Gianna Holt

Prepared by: Paul Wojtowicz, Certified Inspector

At your request, a visual inspection of the above referenced property was conducted on October 9, 2020. An earnest effort was made on your behalf to discover all visible defects.

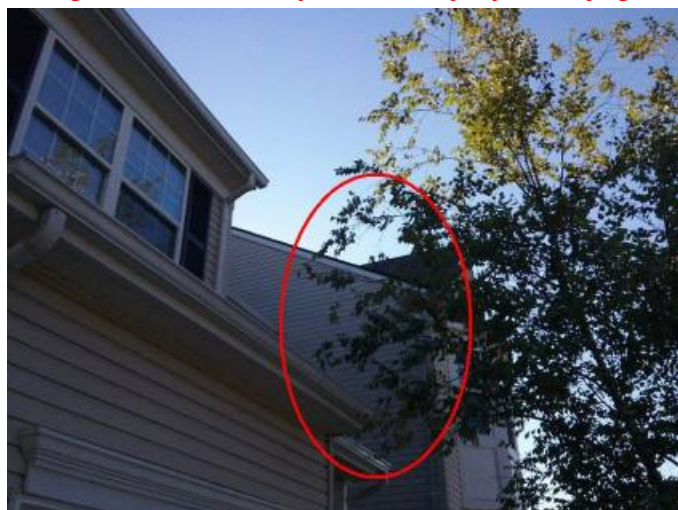
Action Necessary - The trees on the property were in a condition that requires action to prevent potential issues with falling branches. The trees should be evaluated by a qualified arborist to determine what maintenance or treatment is required. Trees overhanging the structure need to be trimmed so that limbs, leaves, and rain will not drop off the tree onto the roof covering and clog the gutters, damage the roof, or promote moss growth. Trees that rub against the roof can cause severe damage and can drastically reduce the life of the roofing material.

Estimated Range of Costs to Repair or Remediate = Further evaluation is required by a qualified tree company.

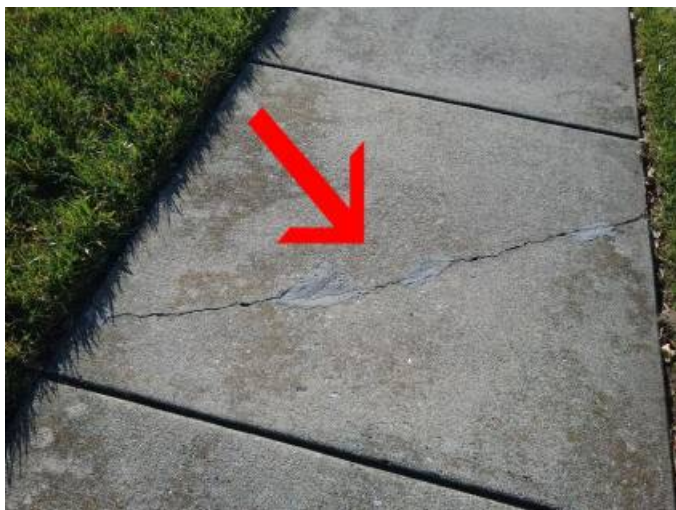
Attention Needed - The walkways need attention and minor repair to prevent further deterioration. The cracks in the walkways need to be sealed to prevent further damage. The freeze-thaw cycle may cause differential settlement and enlarge existing cracks.

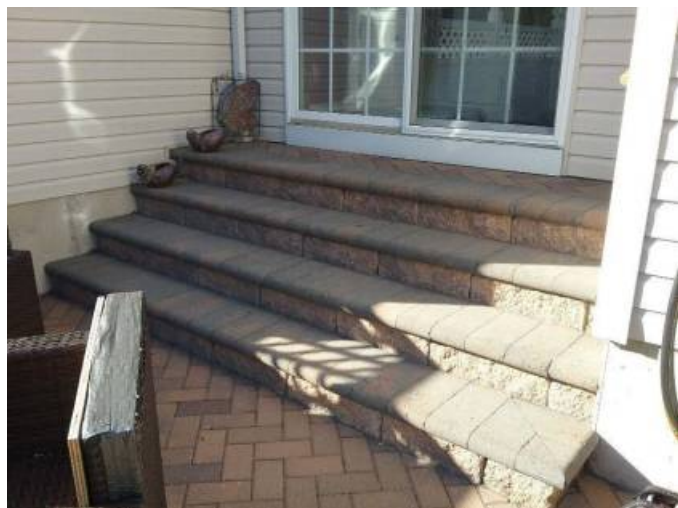
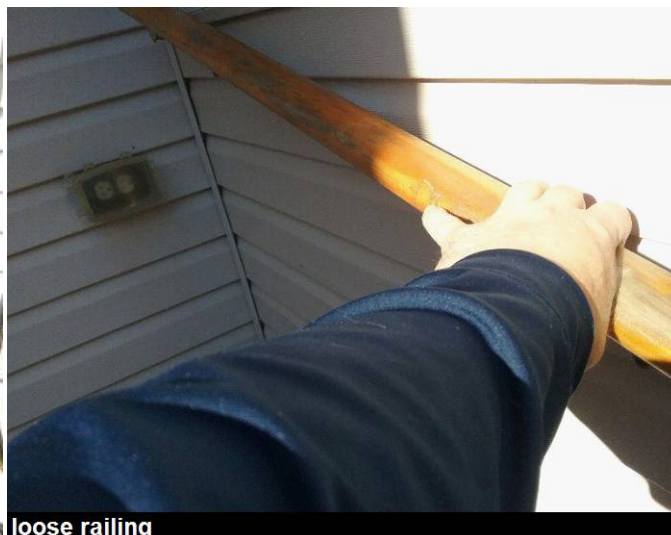
Attention Needed - The loose handrail needs some attention. Tighten.

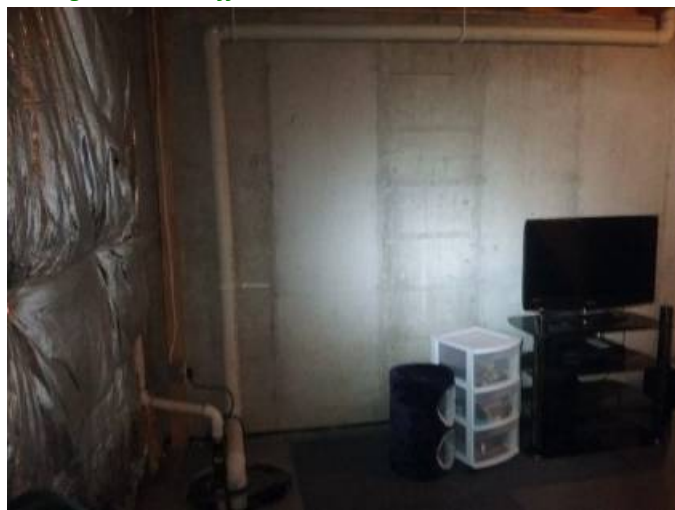
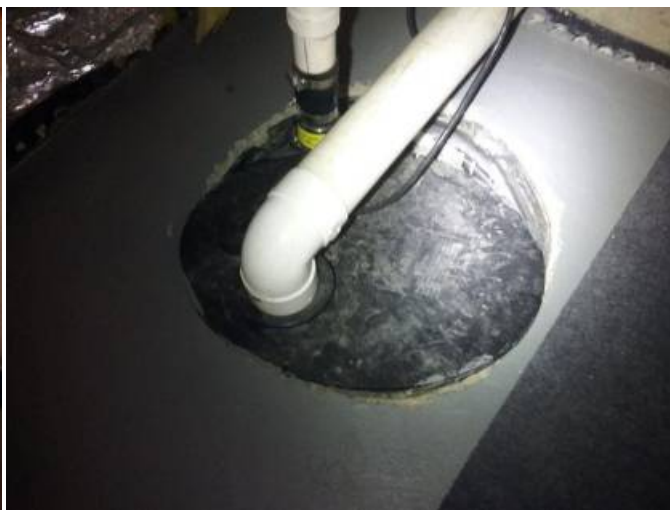
The inspector observed what is believed to be a passive radon mitigation system. This simply means there is piping installed in the structure for future use should it be determined an active mitigation system is required. A passive system does NOT mitigate any radon. It is highly recommended that a radon test be performed to determine the actual radon levels within the structure. Our company, Ad-In Inspections, is a radon testing firm. Ask your inspector for more information about radon testing or call the office at 856-220-5824 to schedule a radon test. Not sealed.

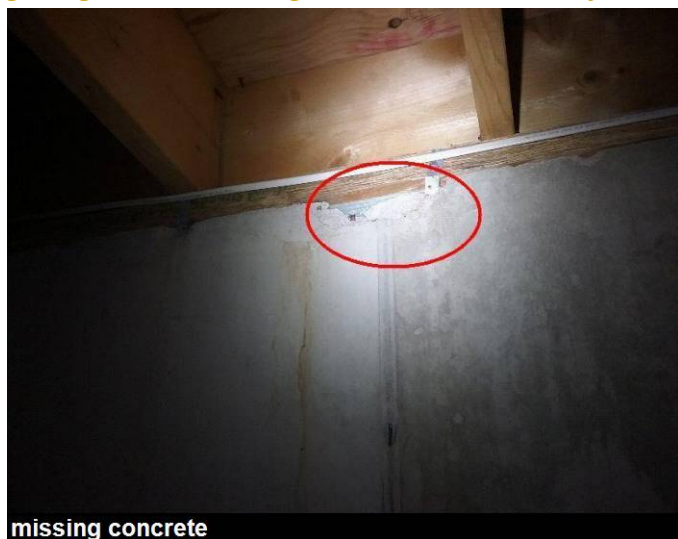
missing concrete

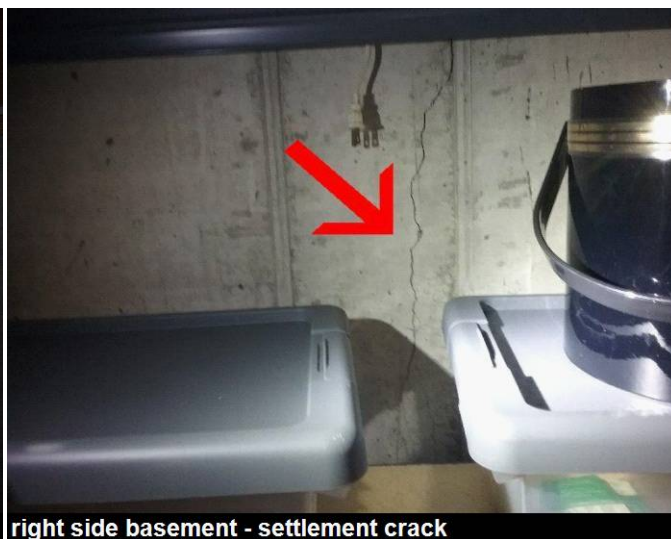
Vertical cracks were noted in at least one exterior wall. These cracks should be monitored for future movement. If the cracks get larger, a structural engineer should be consulted for recommended remedial action.

right side basement - settlement crack

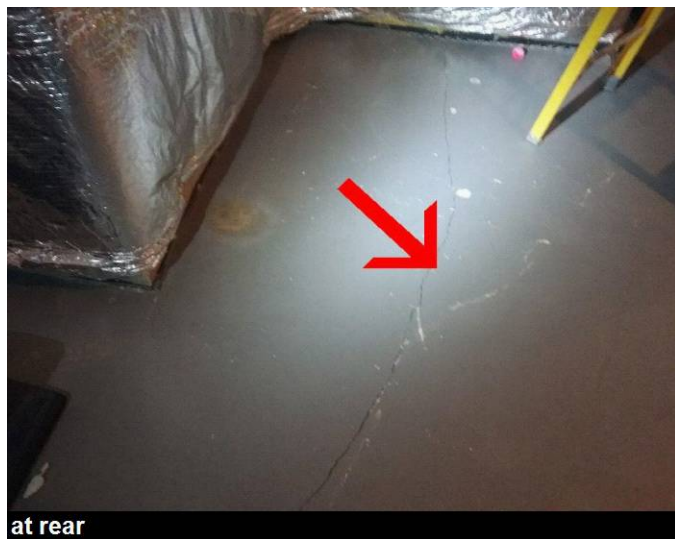
at rear

Yes - Cracks were noted in the slab floor. Unless otherwise noted, the cracks appeared to be nothing more than curing cracks. There was stored items on the floor that significantly reduced the inspectors visibility.

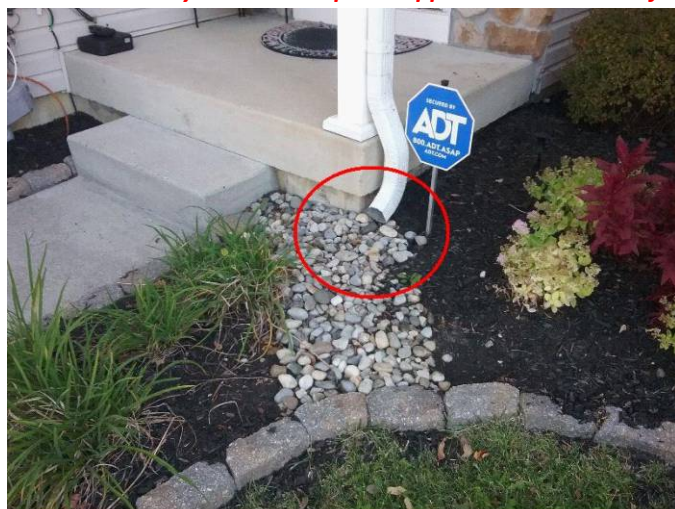
Action Necessary - The downspouts appear to be in need of repair or replacement in order to function properly, Damaged.

extend downspout

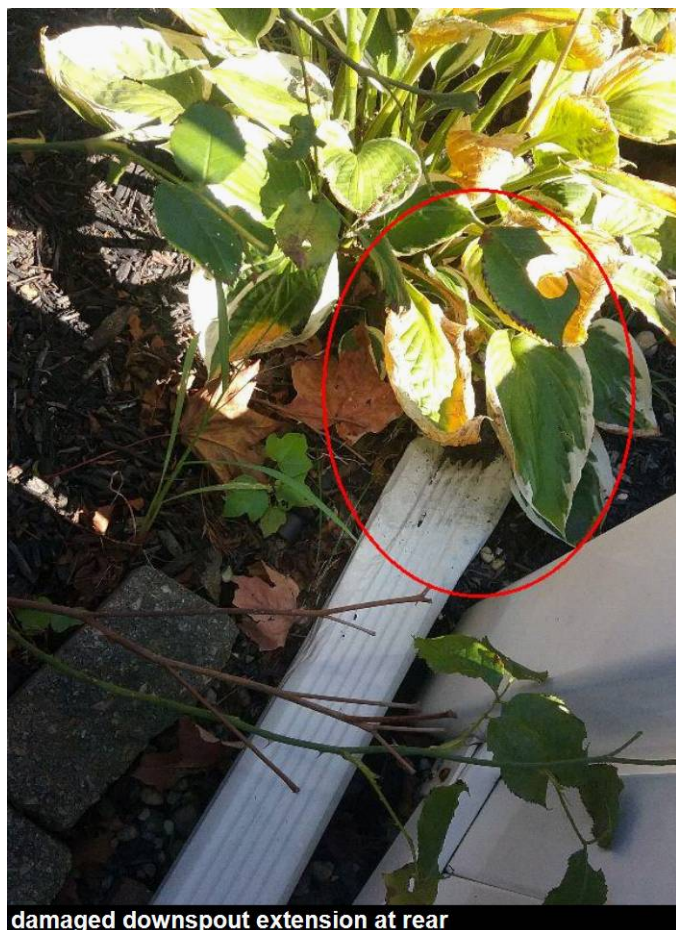
damaged downspout extension at rear

Action Necessary - The downspout appears to be in need of repair or replacement in order to function properly at rear patio

Estimated Range of Costs to Repair or Remediate = \$20

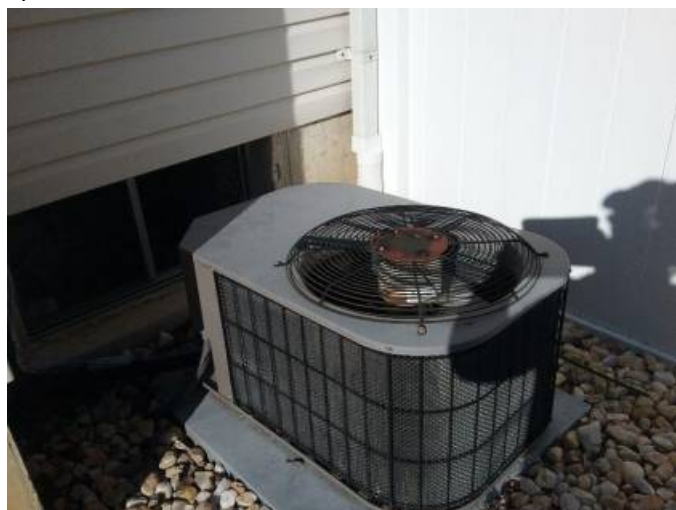
The typical service life for an AC unit is 12 - 15 years. Attention Needed - The age and/or condition of the AC unit is such that you may need to replace it in the near future. This unit was manufactured about 2004.

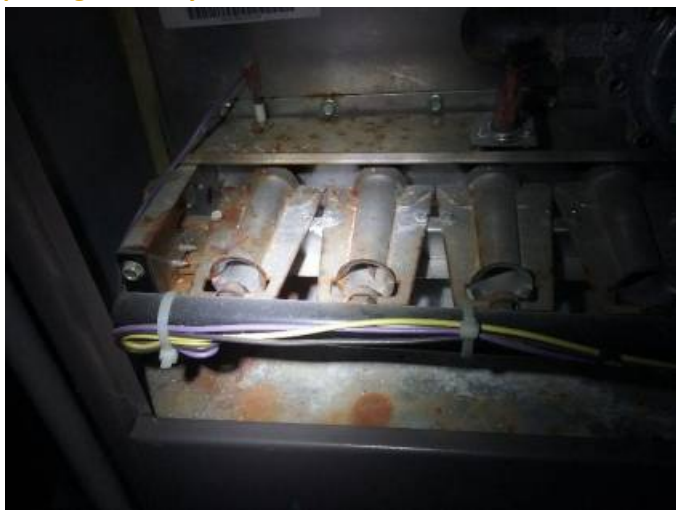
Unit was operational at the time of inspection. General condition appears serviceable, *Attention Needed - Corrosion is noted on the inside or outside of the cabinet. There was no visible moisture in or on the cabinet. Corrosion is normally due to leaking from the evaporator coil drip pan or leaks in the condensation collection system. The inspector recommends that a qualified professional HVAC technician inspect and service the system as needed. Suggest cleaning/servicing blower motor, pilot light, vent system and burners.*

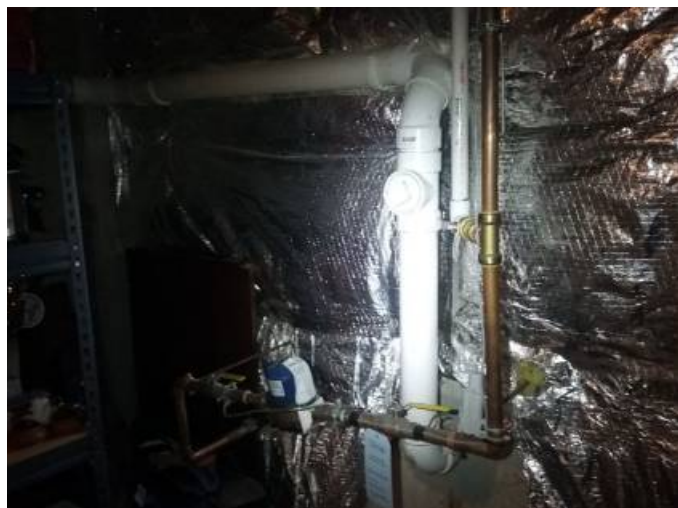
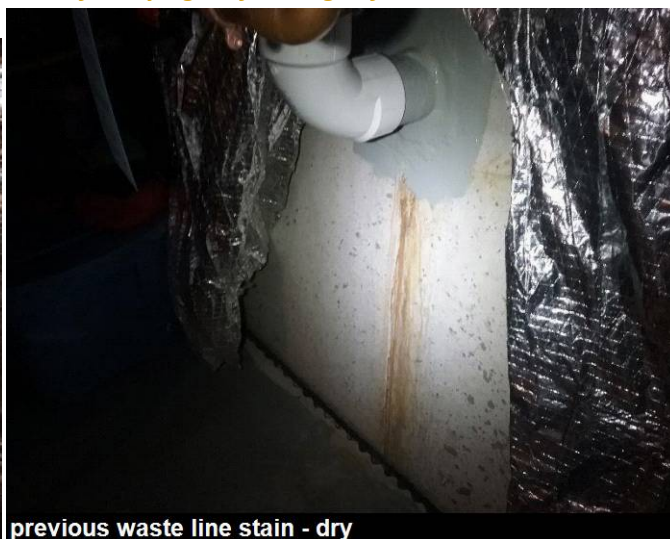
Attention Needed - There is deterioration noted in the visible portions of the waste lines that requires monitoring. Rust was noted on the cast iron main stack visible from the basement. Watch for any signs of leaking or failure. Previous leak.

previous waste line stain - dry

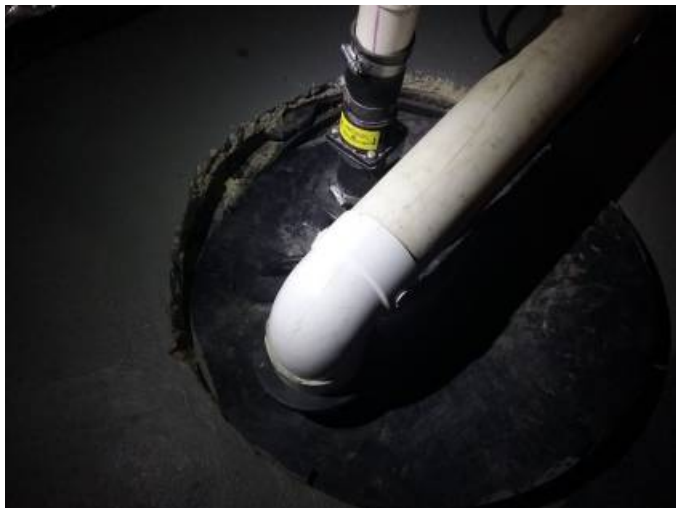
There is no backup sump pump installed. The inspector highly recommends installing a battery or water powered (venturi type) backup system. Installing a backup system will ensure system functionality in event of a power failure. No Visibility to Inspect - The sump pump cover was in place so the inspector could not test the pump or inspect the sump pump connections.

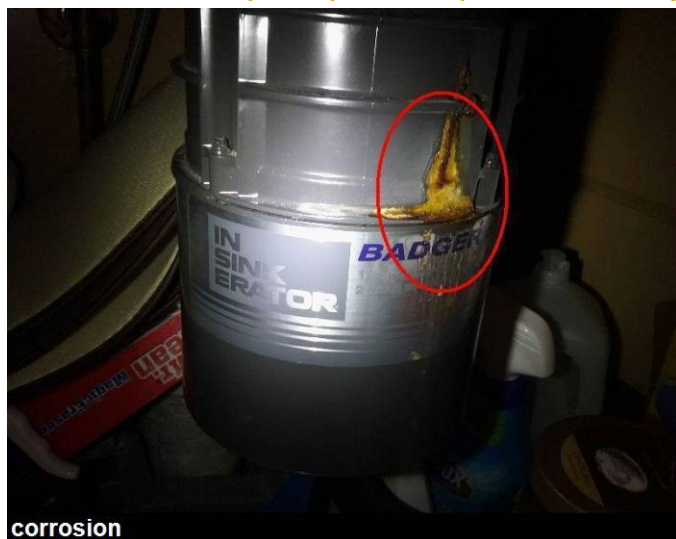
System is Insinkerator. *Attention Needed - Although this unit was operational during the inspection, the age and/or condition is such that you may need to replace it in the near future.*

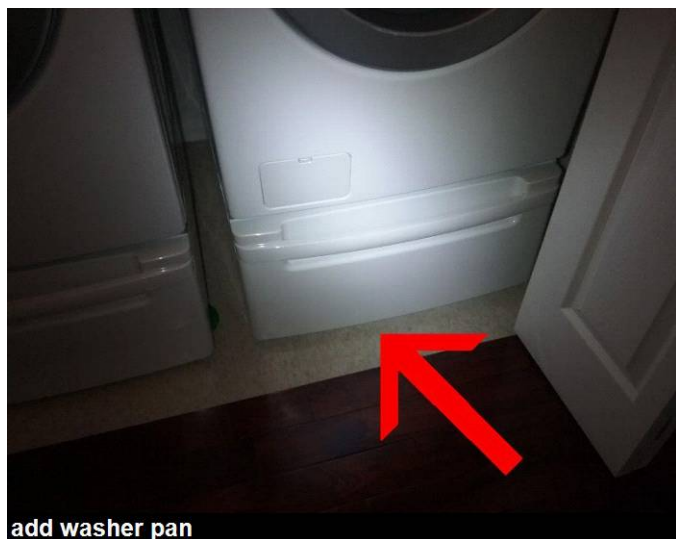
No - There is no washer pan installed under the washing machine. Any time the washing machine is installed on a floor level above another finished floor, a washer pan should be installed to prevent damage caused by an overflowing washer or a leak.

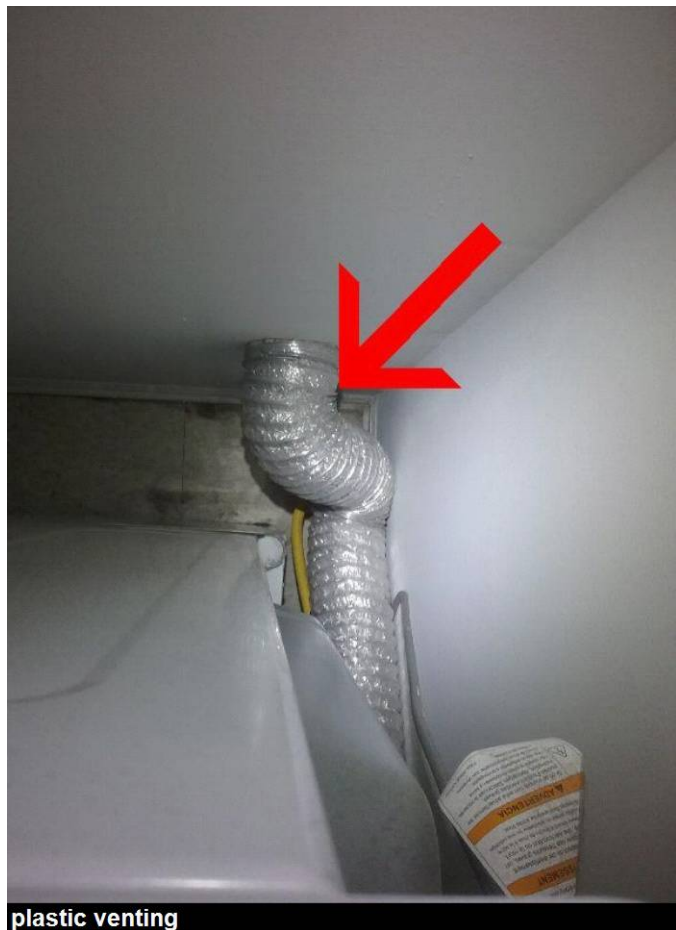
Action Necessary - The dryer ventilation as installed is not functioning properly. Action is required to make the vent work properly. I recommend replacing the plastic vent with a metal dryer vent. Action Necessary - This vent appears to be clogged in the attic. Repair is necessary to clear the vent.

plastic venting

Estimated Range of Costs to Repair or Remediate = \$50 to \$75 (metal vent); \$75 to \$150 (clean dryer vent)

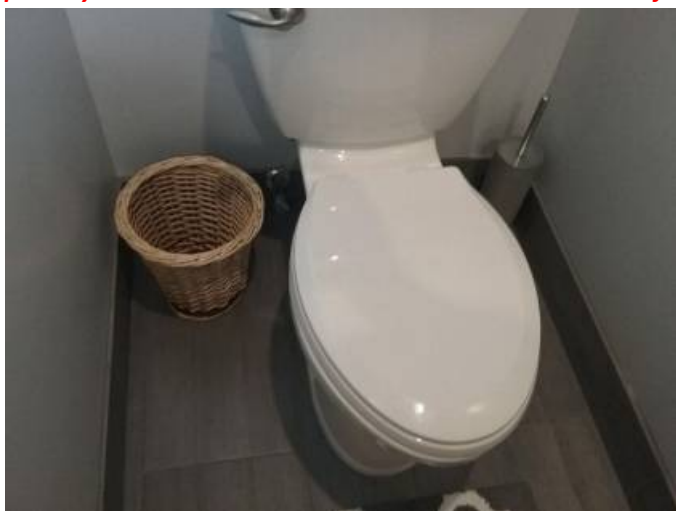
Action Necessary - The toilet in this bathroom needs repair. The toilet is not secure to the floor, allowing it to wobble and possibly leak. Action should be taken to re-secure it to the floor.

Estimated Range of Costs to Repair or Remediate = \$40

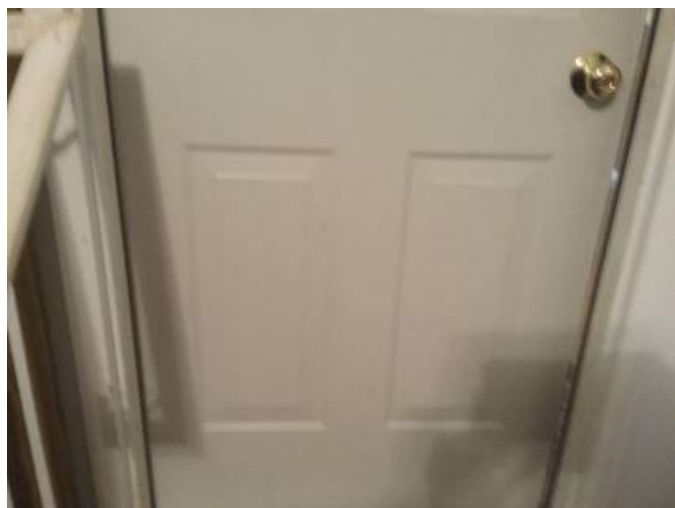
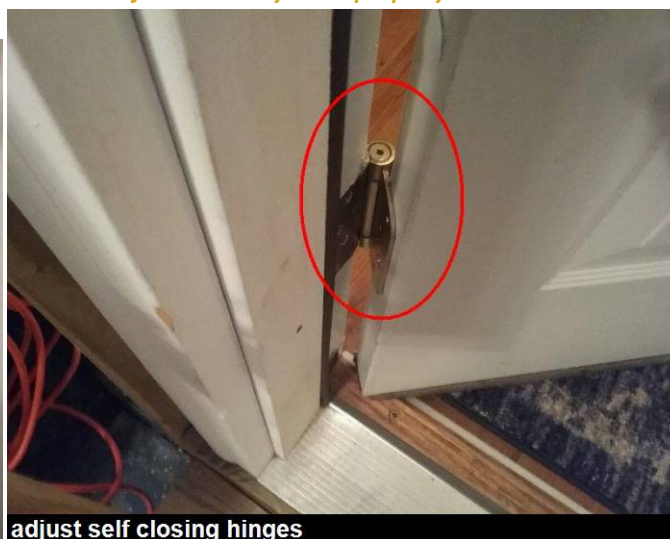
According to the National Fire Protection Association (NFPA) residential fire doors should be "Self-Closing". This means the doors should be equipped with a closing device to cause the door to close and latch each time it is opened. This door was equipped with the self-closing hinges; however, the hinges need to be adjusted so they work properly.
