Confidential Property Inspection Report

Prepared for: Gianna Holt

Prepared by: Paul Wojtowicz, Certified Inspector

At your request, a visual inspection of the above referenced property was conducted on October 9, 2020. An earnest effort was made on your behalf to discover all visible defects.

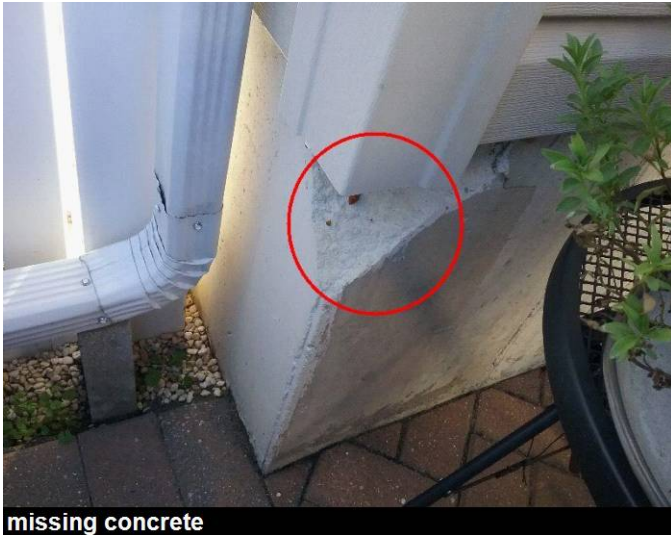
Rear foundation wall.

Location of Wall Cracks and Description:

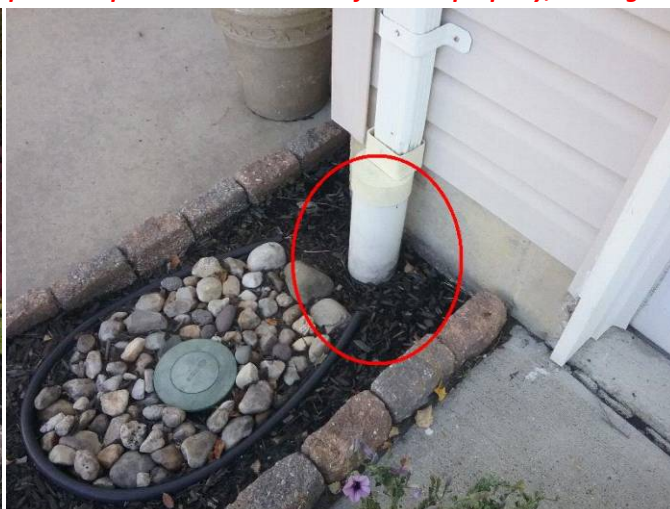
front left - termination point unknown

extend downspout

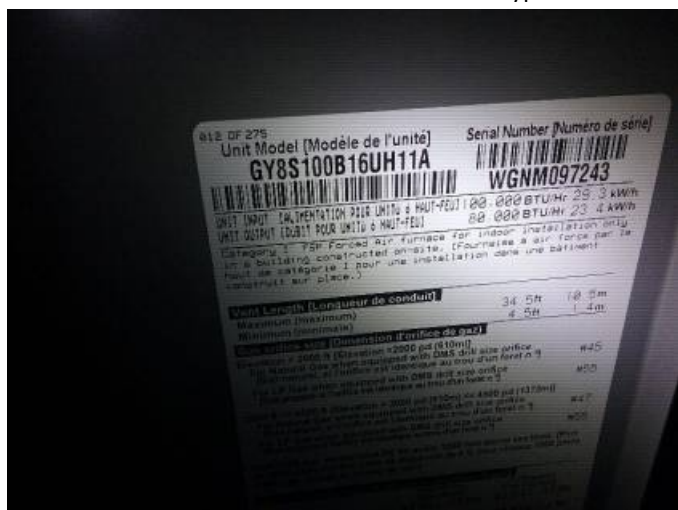
This unit was manufactured **about** 2004. The typical service life for a forced air natural gas furnace is 18 - 20 years.

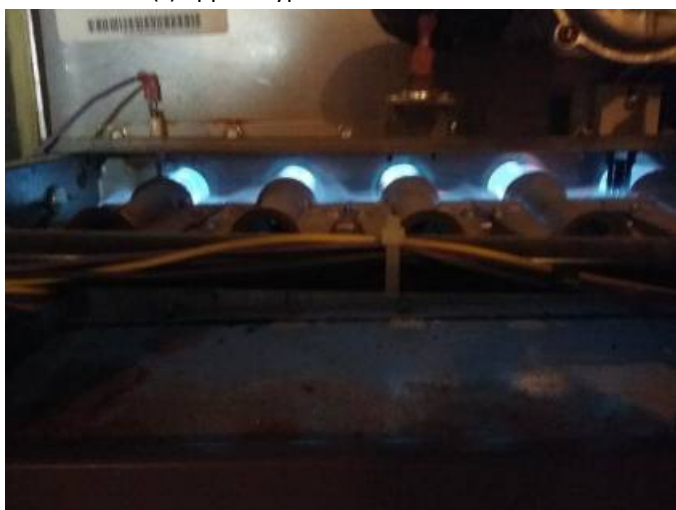
Burner Flame(s) appear typical.

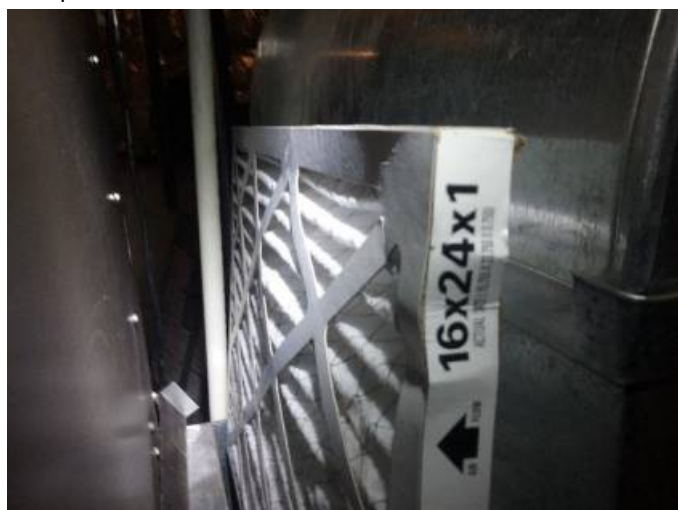
The filter is clean and correctly installed. It is recommended that the filter(s) be changed or cleaned every 30 to 45 days for best performance..

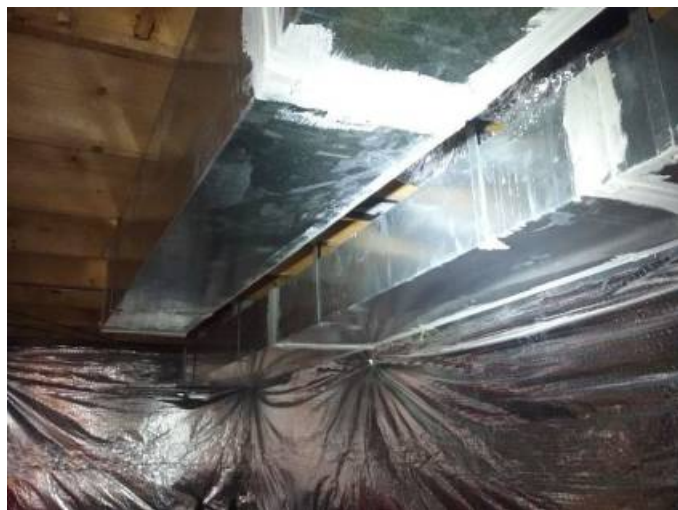
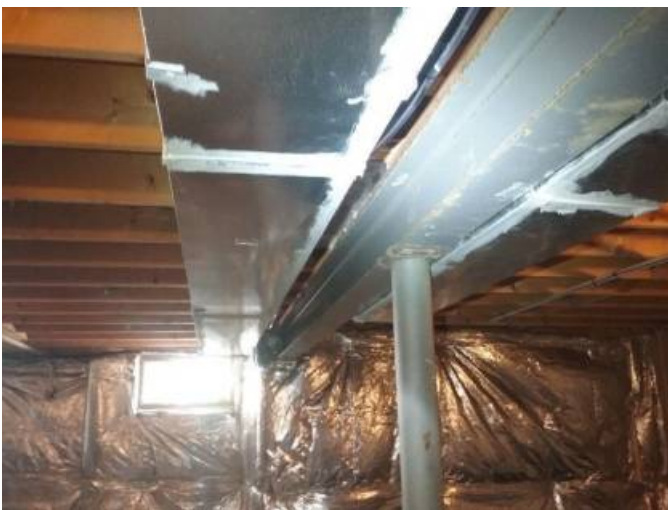
The ductwork appears to be properly installed and supported.

Exposed ductwork in unheated basement space is not insulated. The efficiency of the heating and air conditioning systems is greatly reduced due to the heat loss or gain. Insulation is strongly recommended.

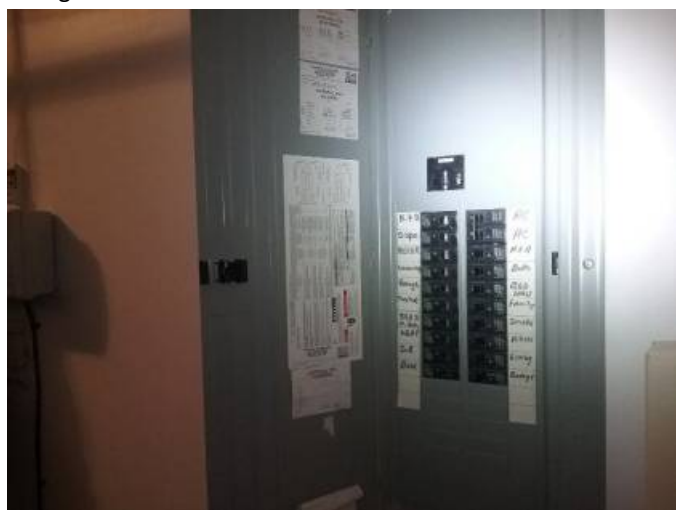
Garage.

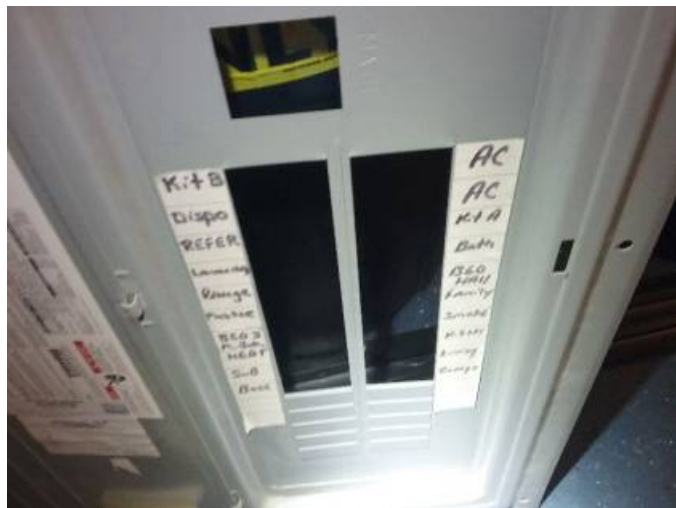
The power panel, as a container for safely covering electrical circuitry and components, is functioning as intended, minimizing the risk of electrical shock. Electrical circuitry wiring in the panel appears neatly arranged with no unallowable splices. Grounding system is present.

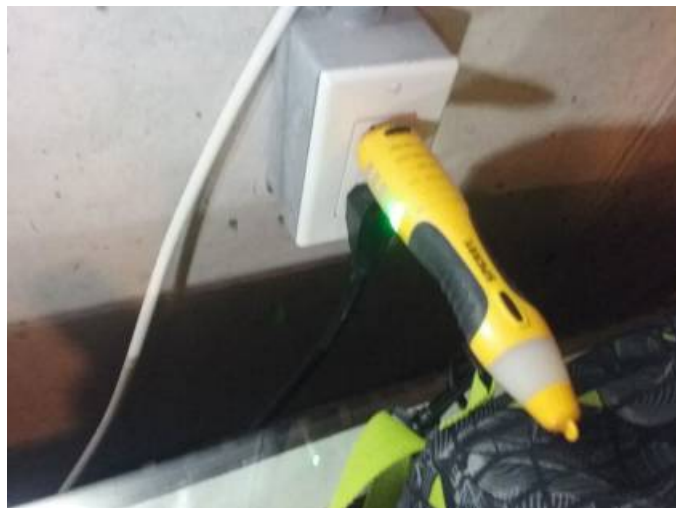
The electrical outlet on the right wall in the garage tested as correctly grounded. One outlet was not accessible behind workbench.

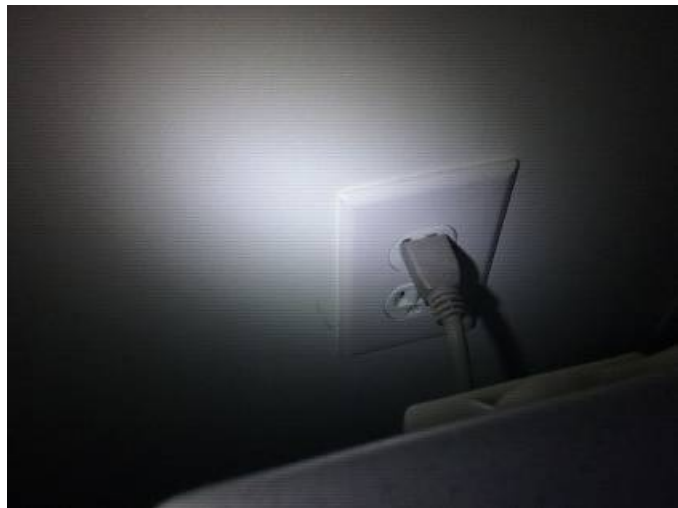
This laundry room does not have a Ground Fault Circuit Interrupt outlet installed. The age of the structure may predate the required installation. However, for safety considerations, it is strongly suggested that one be installed at any location within 6 feet of a water source. As of 2012, the National Electric Code - Article 210.8 requires GFCI protection for all 125-volt, single-phase, 15- and 20 amp receptacles in laundry rooms.

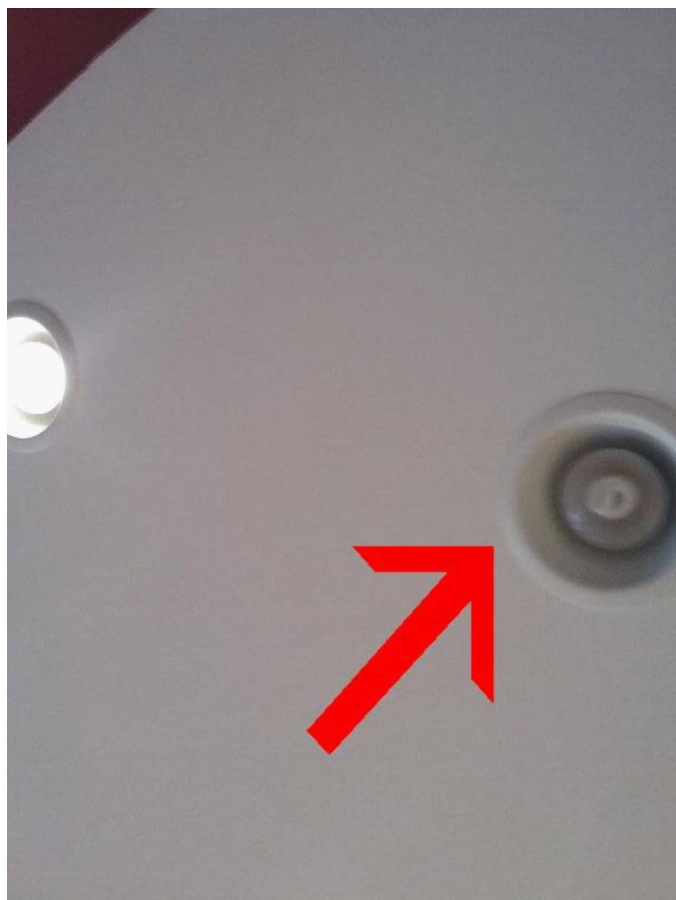
light not functional

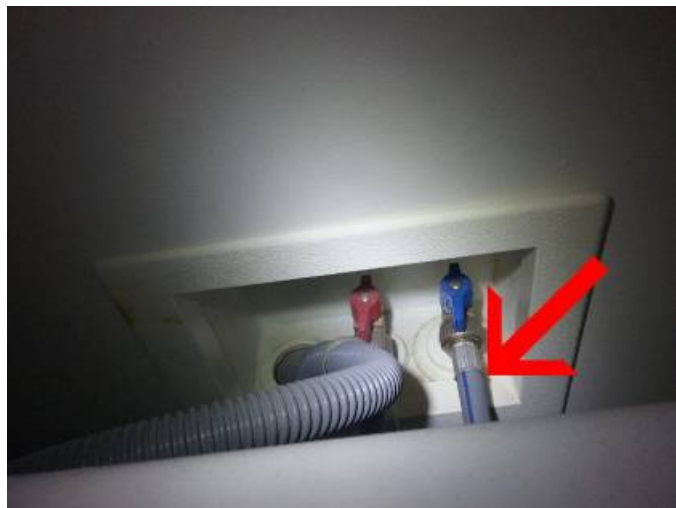
Action Necessary - There were rubber water supply connections/hoses. The connections/hoses should be replaced before a failure occurs. I recommend stainless steel braided hoses.

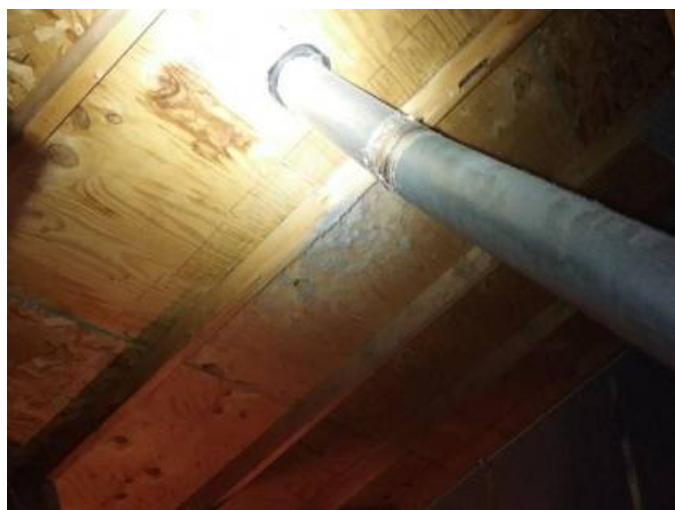
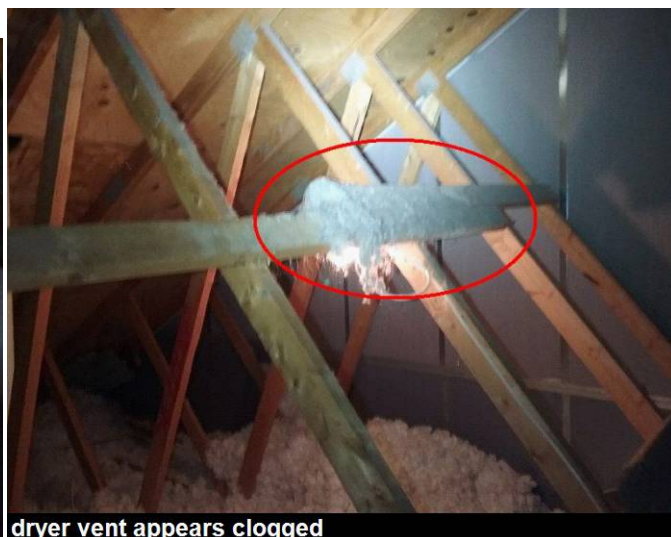
Action Necessary - The dryer ventilation as installed is not functioning properly. Action is required to make the vent work properly. I recommend replacing the plastic vent with a metal dryer vent. Action Necessary - This vent appears to be clogged in the attic. Repair is necessary to clear the vent.

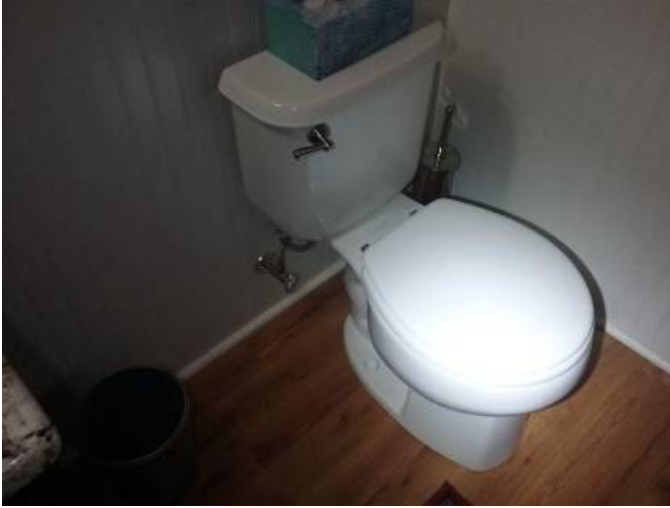
Action Necessary - The toilet in this bathroom needs repair. The toilet is not secure to the floor, allowing it to wobble and possibly leak. Action should be taken to re-secure it to the floor.

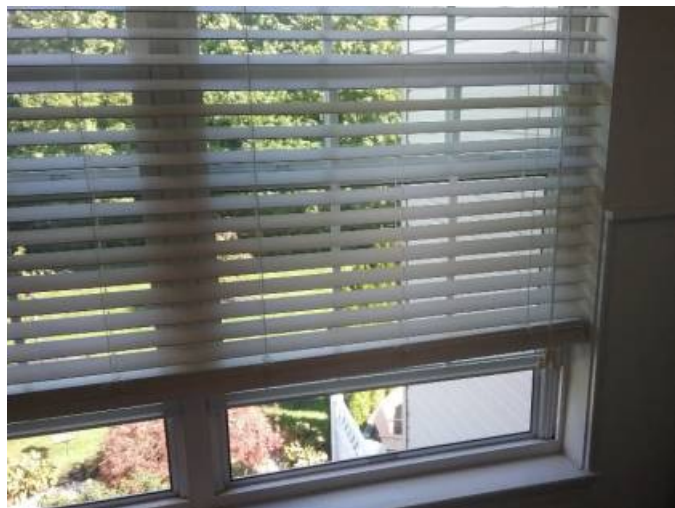
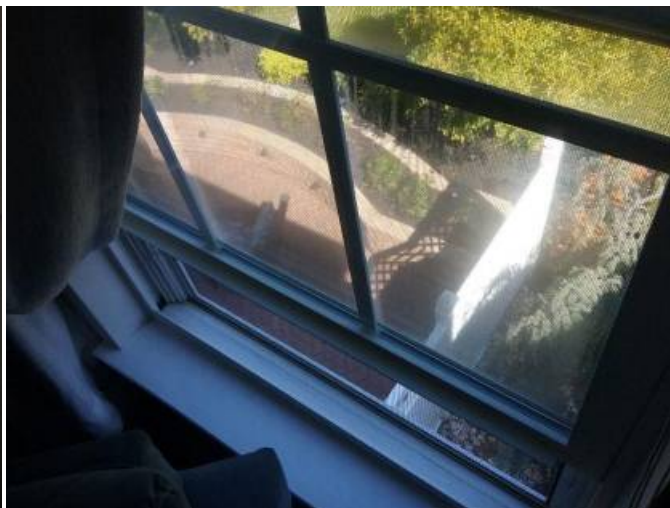
Action Necessary - At least one window or associated hardware in this room needs repair. The thermal seal is broken. Although it is keeping the elements out, it has a clouded appearance and no real thermal efficiency. This condition will worsen.

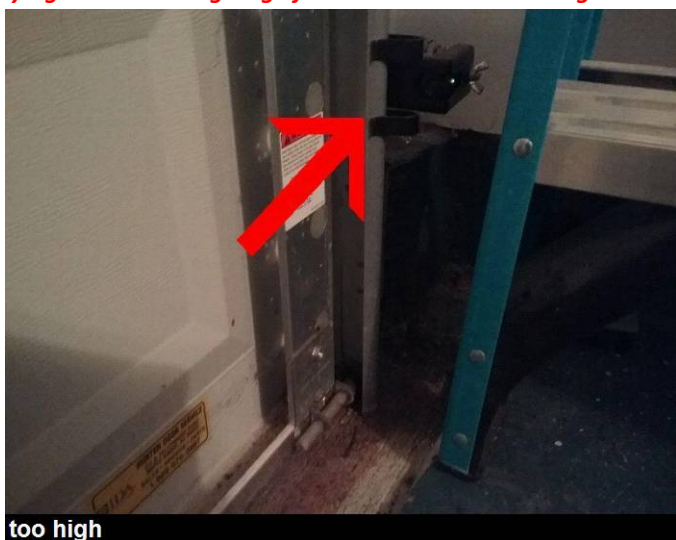
Yes - The door opener is equipped with an automatic reverse safety switch. The safety reverse switch worked when it met resistance. *There is an electronic beam safety reverse system installed. The electronic beam safety beam is installed too high. The top of each photoelectric eye lens is to be installed no higher than six (6) inches above the garage floor. If installation is above six (6) inches, the photoelectric eyes may not detect what they are intended to protect, an individual lying down on the garage floor under the descending door.*
